D'APPOLONIA CONSULTING ENGINEERS INC PITTSBURGH PA  
NATIONAL DAM INSPECTION PROGRAM. RACCOON CREEK STATE PARK DAM (U)  
JUN 79 L D ANDERSEN

PHASE I REPORT  
NATIONAL DAM INSPECTION PROGRAM

NAME OF DAM: Raccoon Creek State Park Dam  
STATE LOCATED: Pennsylvania  
COUNTY LOCATED: Beaver County  
STREAM: Traverse Creek, a tributary of Raccoon Creek  
SIZE CLASSIFICATION: Intermediate  
HAZARD CLASSIFICATION: High  
DATE OF INSPECTION: December 13, 1978 and April 16, 1979

PHASE I REPORT  
NATIONAL DAM INSPECTION PROGRAM  
RACCOON CREEK STATE PARK DAM  
NDI I.D. NO. PA-262  
DER I.D. NO. 4-34

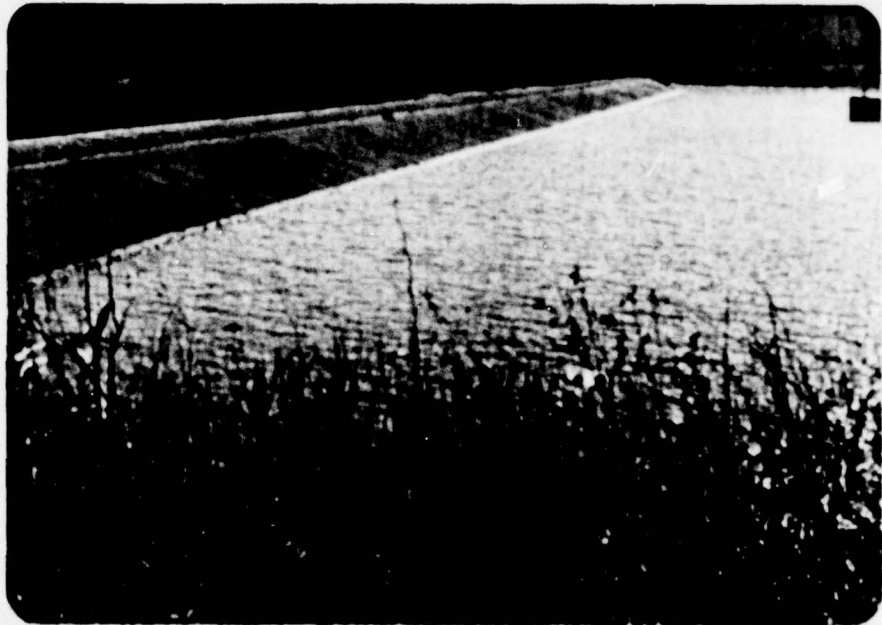
Upstream Face

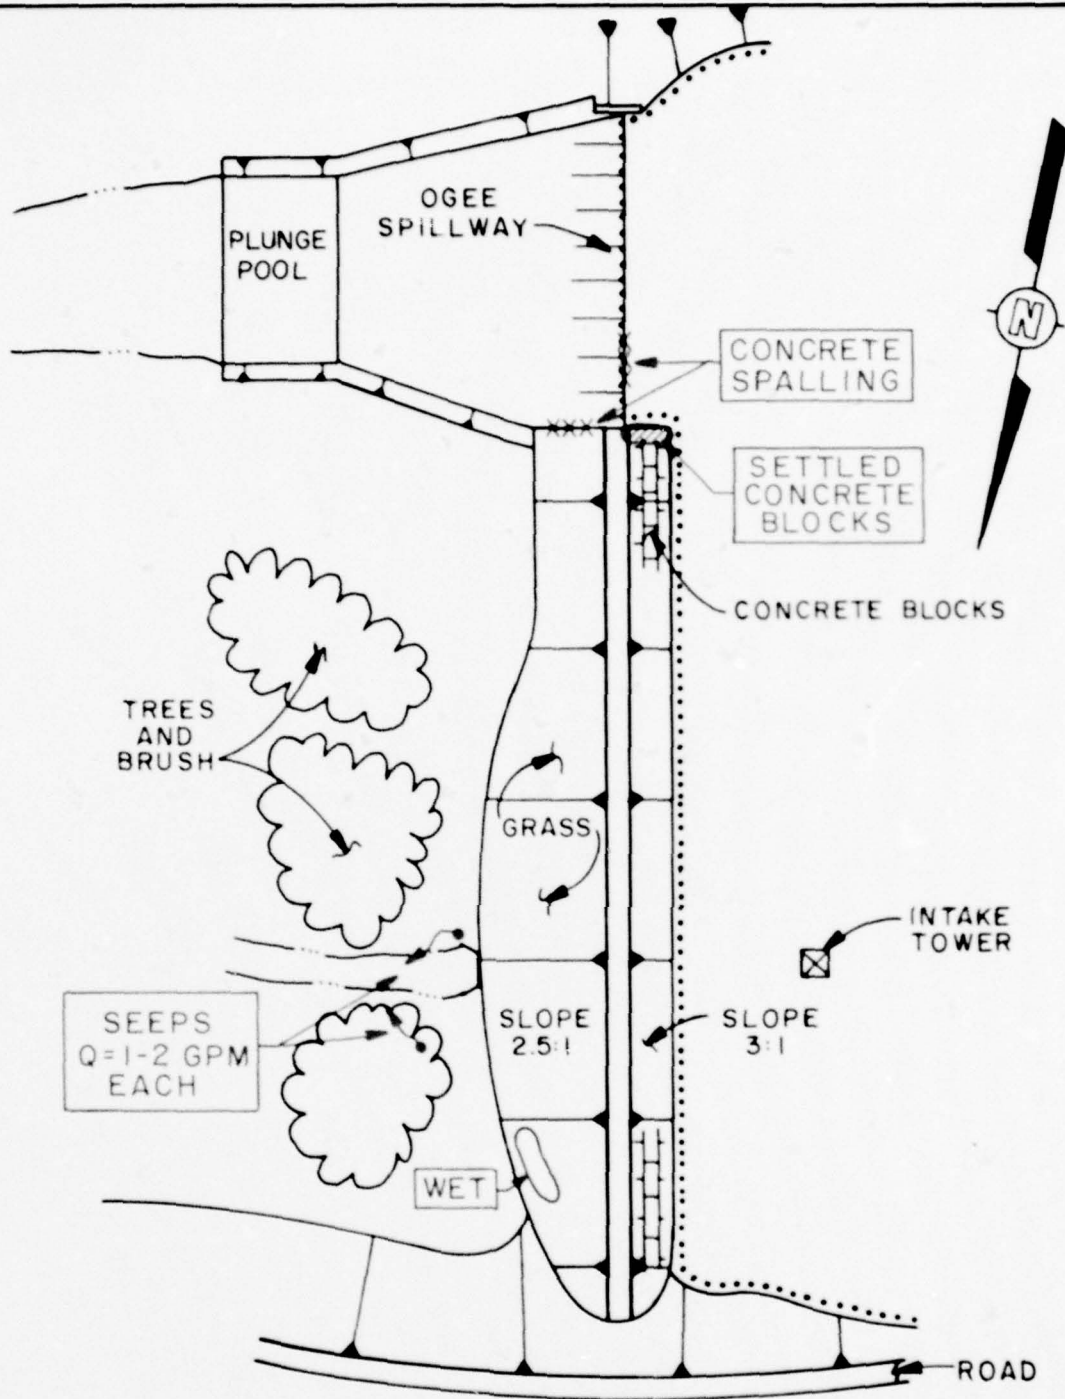
The crest of the embankment was surveyed relative to the spillway crest level and was found to be at or slightly above the design crest level. The profile of the crest is illustrated on Plate 10.

1. SPILLWAY FREEBOARD = 8.0 FEET.
2. POOL LEVEL DATE OF INSPECTION: 0.1 FT. ABOVE SPILLWAY CREST.

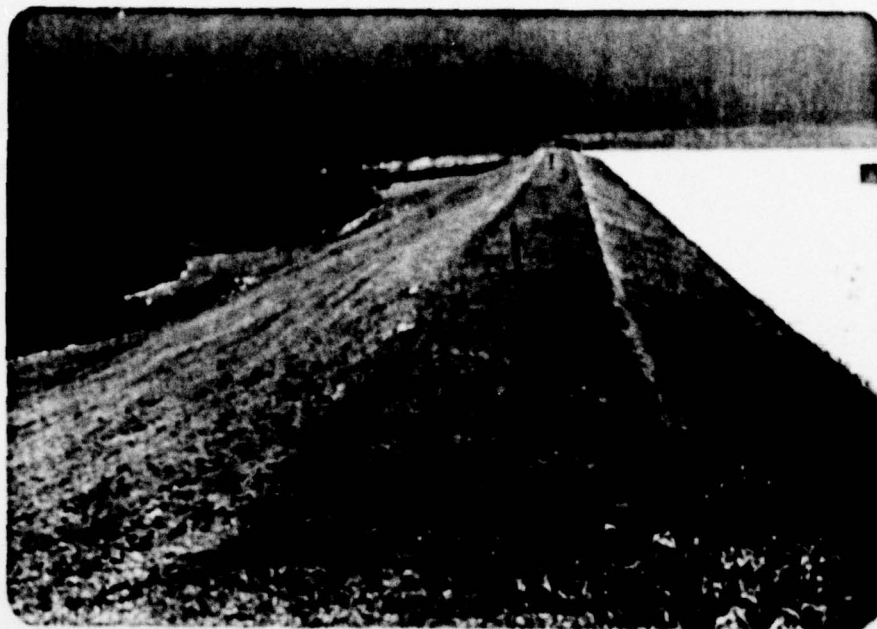
Photograph No. 1  
Crest (looking south).

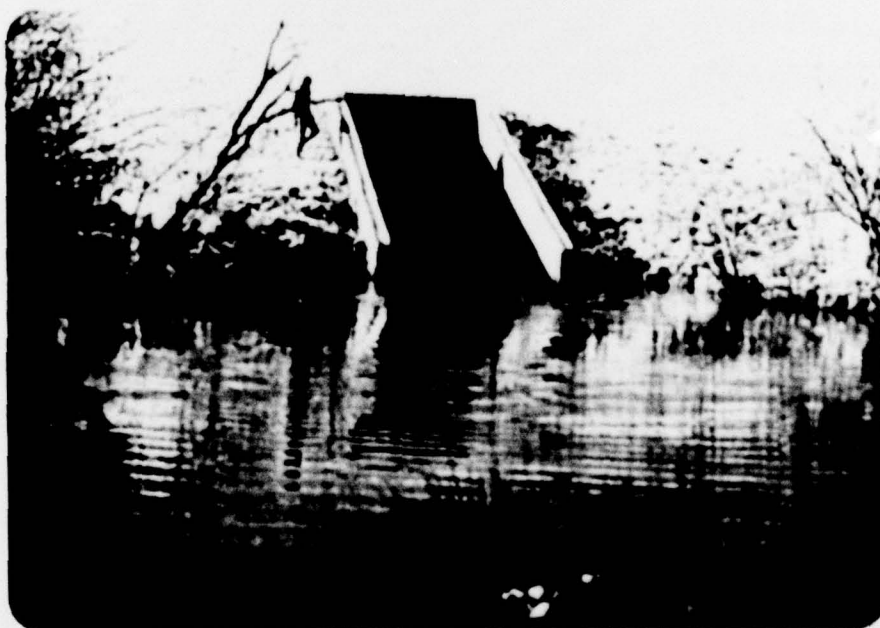
Photograph No. 6  
Downstream end of outlet conduit.
